RAILWAY INVESTIGATION REPORT

R99T0031

DERAILMENT

CANADIAN NATIONAL
TRAIN NO. CN M-304-41-05
MILE 255.1, RUEL SUBDIVISION
NESWABIN, ONTARIO
06 FEBRUARY 1999

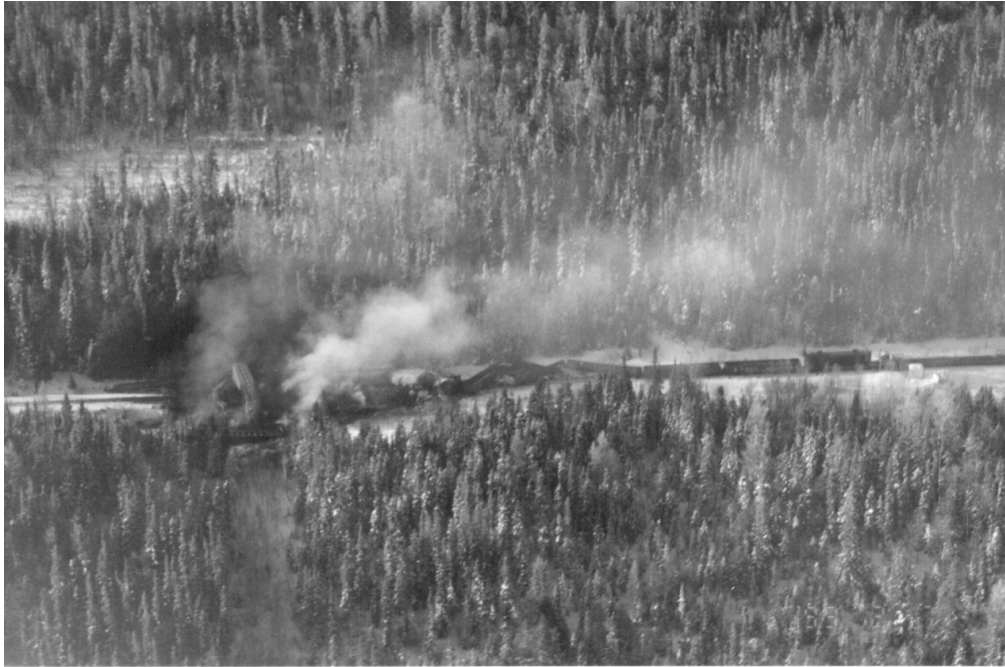
Figure 2 - Aerial photograph of accident site

A subsequent aerial inspection of the train revealed that 20 cars had derailed: the 21st to the 40th behind the locomotives. The bulkhead flat car, CN 604697, was found to have a burnt-off axle journal (BOJ)⁵, later determined to have been located at the L-3 position, which was adjacent to the lead wheel of the trailing truck on the south rail (95th axle). The derailed cars included a loaded tank car of liquefied petroleum gas (LPG) and two tank cars of benzene, a flammable liquid mixture (see section 1.3). One of the tank cars of benzene, AGEX 1001, was badly damaged resulting in a total loss of product. The liquid benzene and some lumber that was strewn about the accident site from some bulkhead flat cars that were destroyed in the accident fuelled a large fire that burned for several days. The jacket of the loaded tank car of LPG, CGTX 63501, was scorched by the heat from the fire; however, there was no release of product (see Figure 3). The emergency response procedures were carried out in a timely and effective manner.

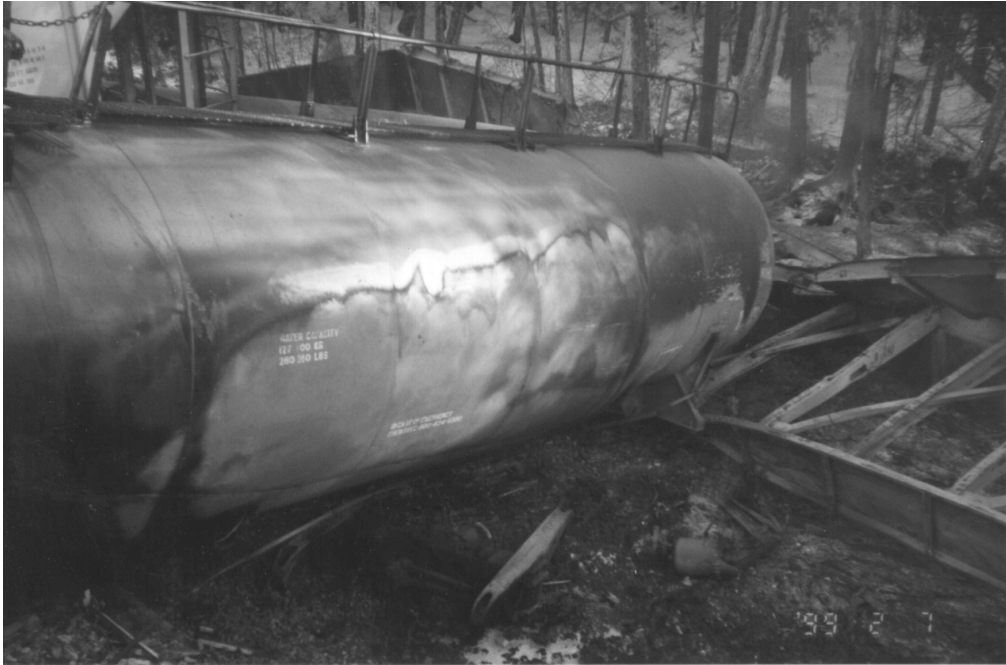
Figure 3 - Fire-damaged jacket of loaded tank car of LPG
(CGTX 63501)

The tank car of LPG, CGTX 63501, was built to specification DOT-112J340W. The tank car was heavily damaged but experienced no loss of product.

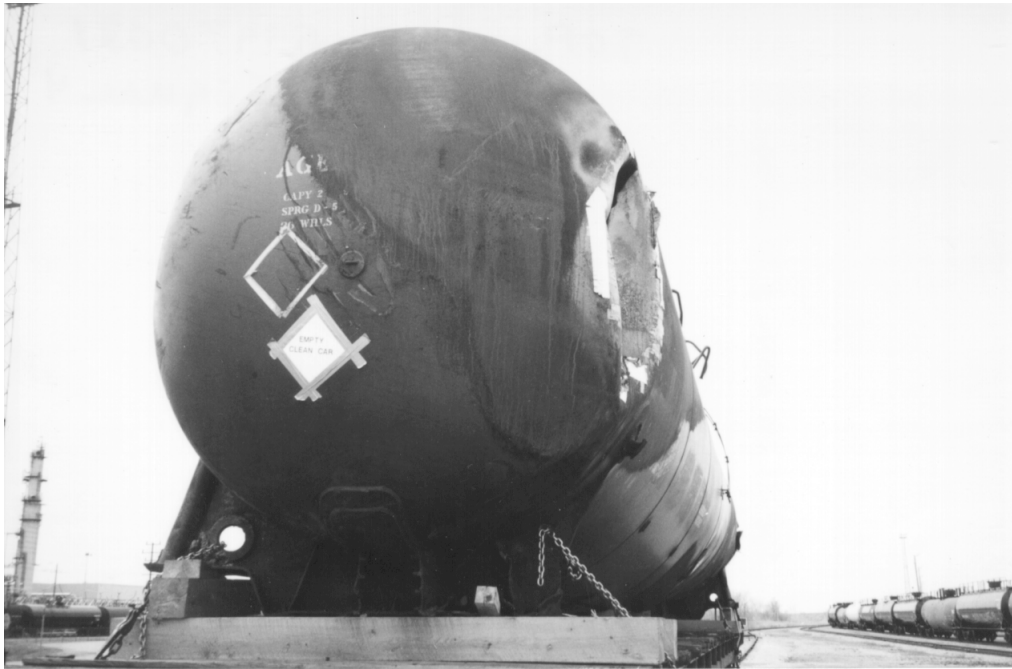
The tank cars of benzene, AGEX 1001 and PROX 41841, were built to specification DOT-111A100W1. Car AGEX 1001 was badly damaged during the derailment sequence and lost its entire contents (see Figure 4). The susceptibility of minimum standard Class 111A cars to experience damage during a derailment has been known throughout the North American railway industry, including railway safety regulators, for a considerable time.

Figure 4 - Damaged benzene tank car (AGEX 1001)
